**Geotechnical Society of Edmonton Annual Student Presentations**

# Landslide hazard assessment, Town of Peace River, AB

Focusing on the landslide movements and their behaviors

### **Tai-Hoon KIM**

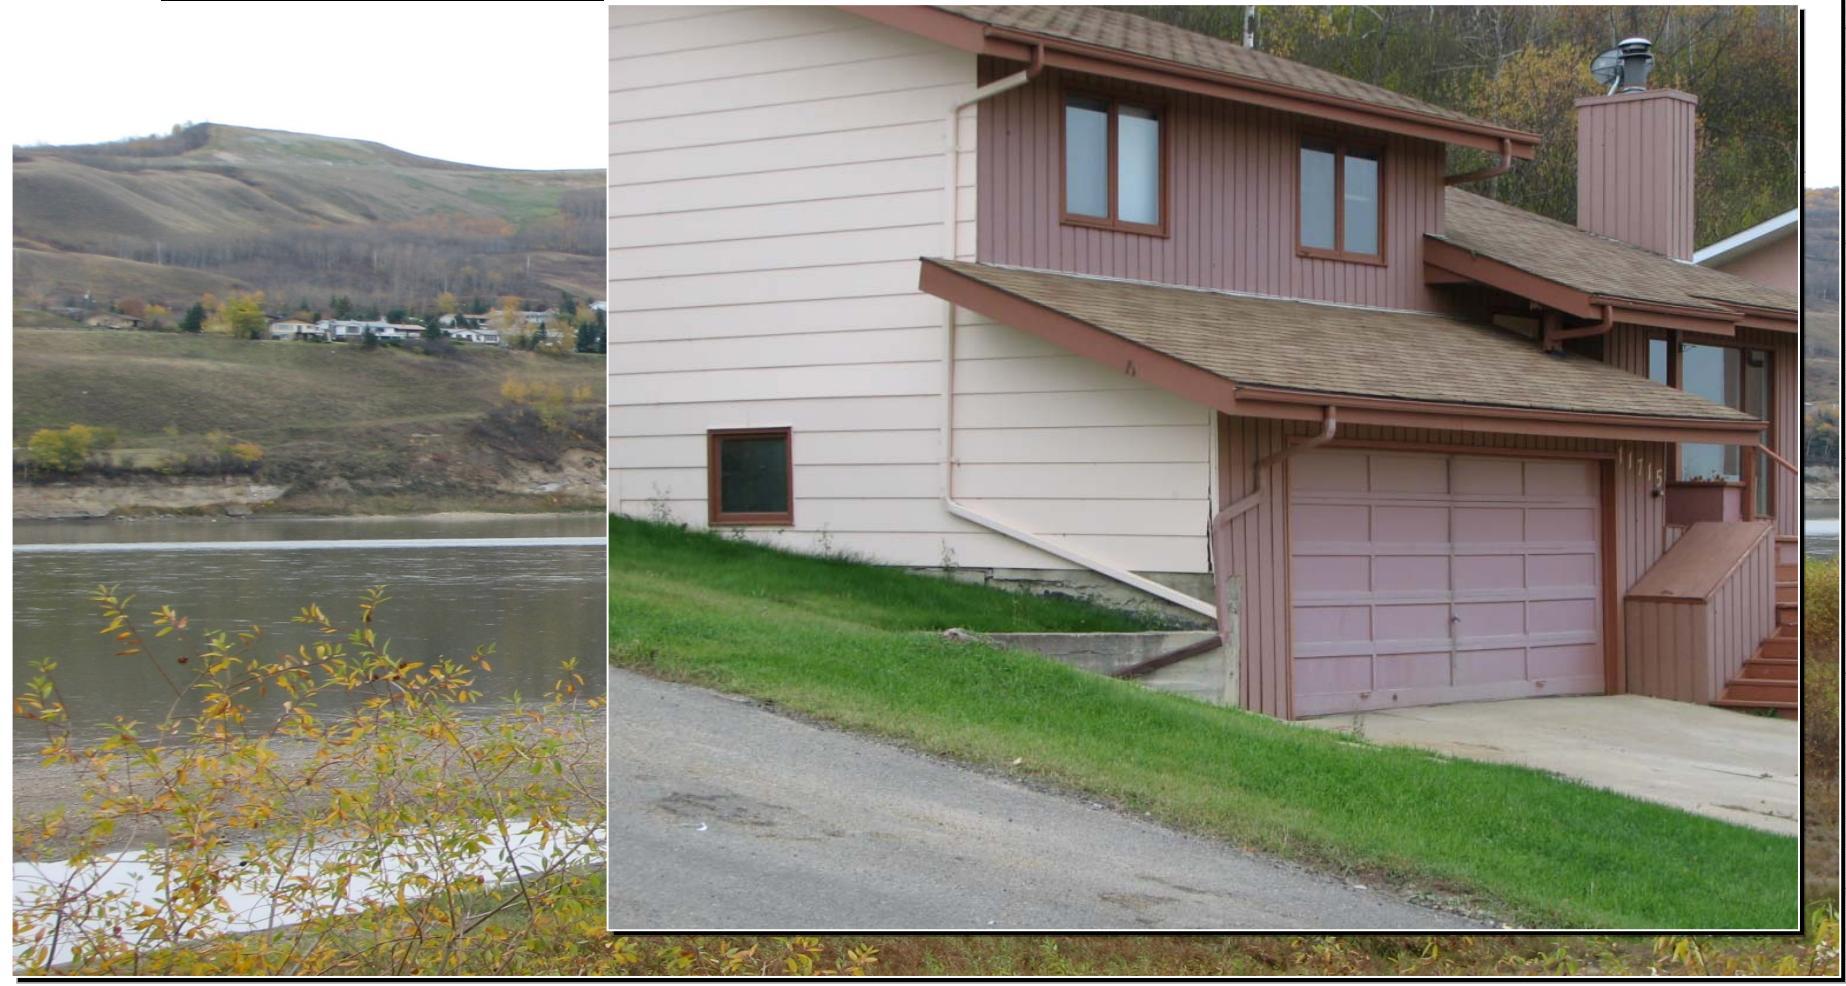
### <u>99/101<sup>st</sup> (Cont'd)</u>

- Instability started in 1973
- First major problem: 1985
- House removed: 1990-1991
- Recent movement started in 1992 and accelerated in 1993
- Large scaled remediation established since 1993

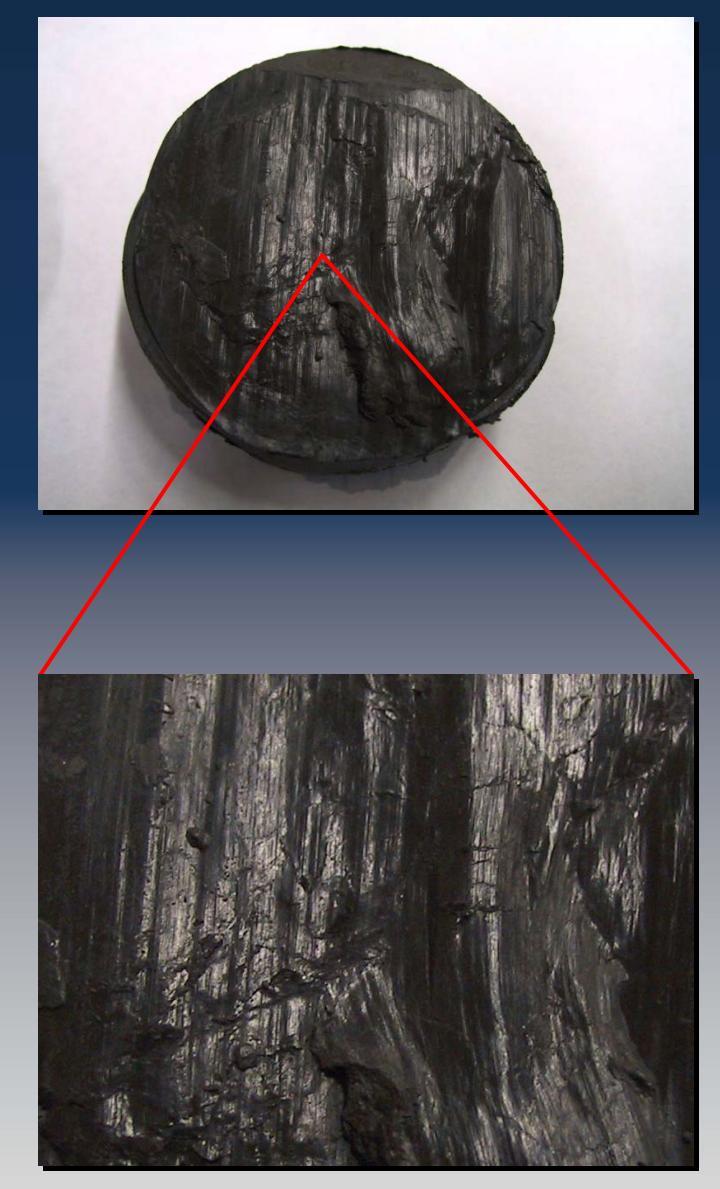
#### Sample B

Advance phase glaciolacustrine sediments

**Formed Slickensides**
