# Ground Improvement for Mitigation of Failure Risks to Existing Embankment Dams

James K. Mitchell, Sc.D., P.E., Dist. M.ASCE

October 6, 2010

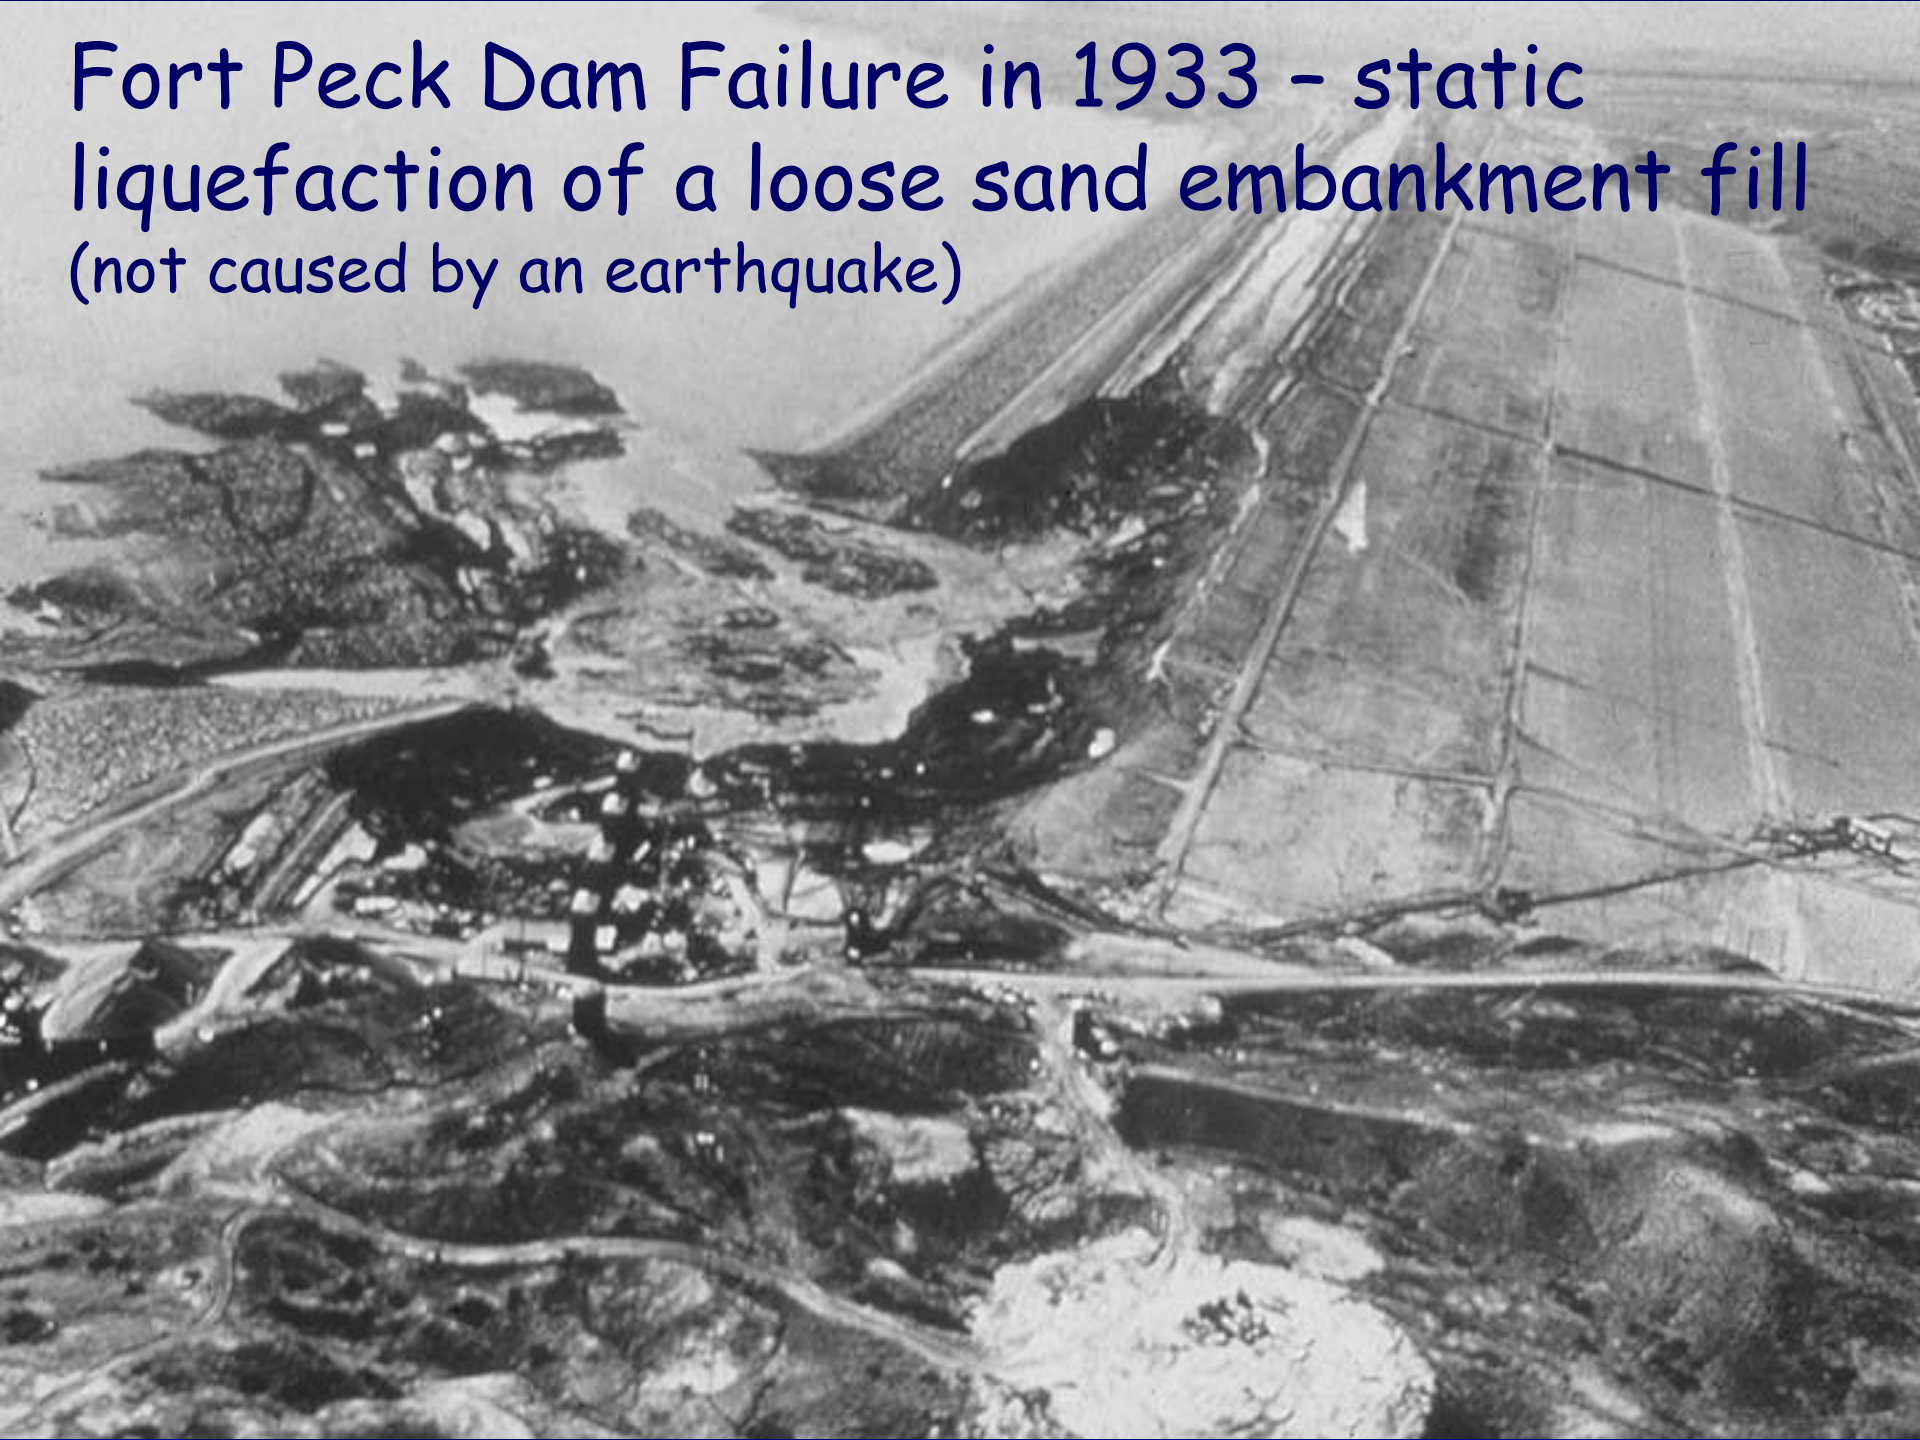
Fort Peck Dam Failure in 1933 - static  
liquefaction of a loose sand embankment fill  
(not caused by an earthquake)

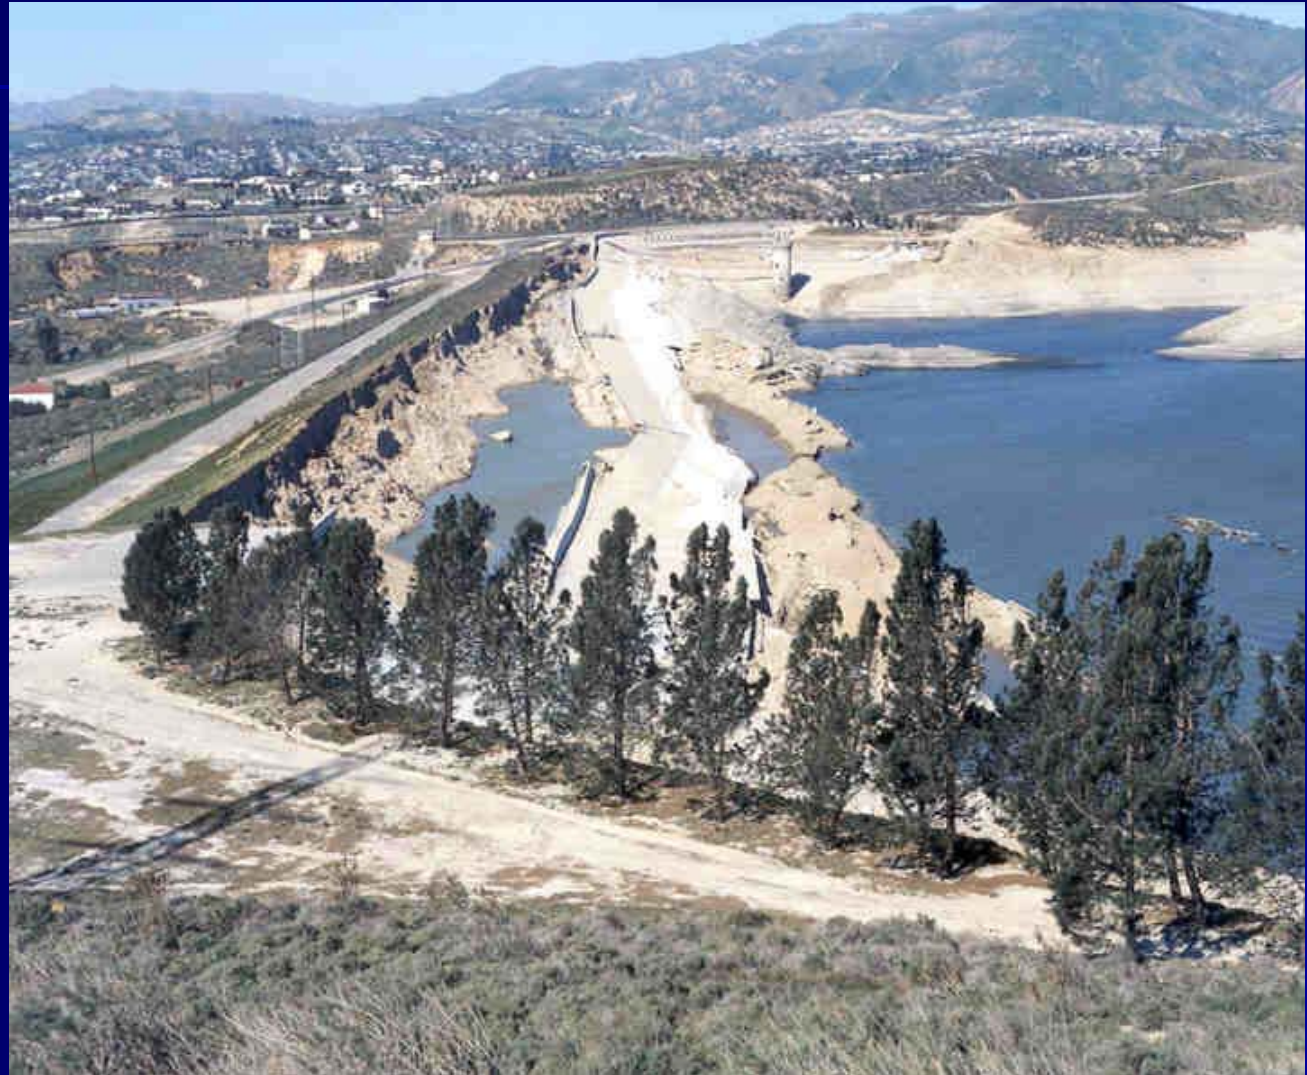
# 1971 Slide - Lower San Fernando Dam

Photo taken during reservoir emptying after the earthquake to protect the large population at risk downstream

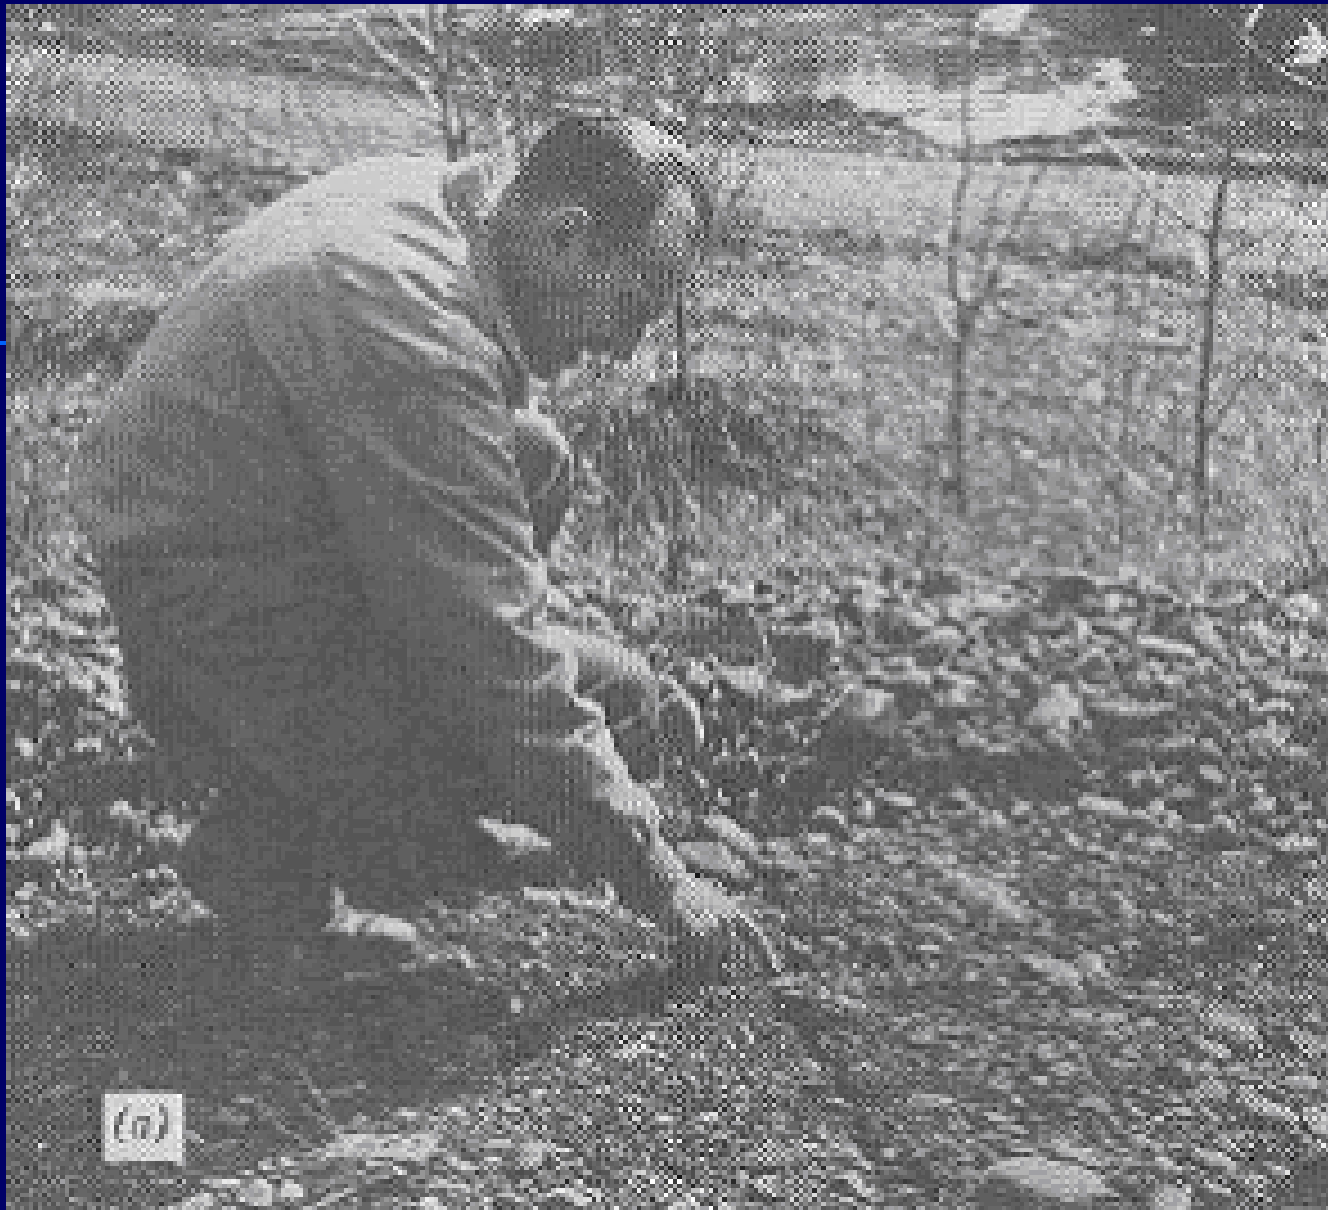
Settlement and  
cracking at Hebgen  
Dam, MT in 1959 EQ

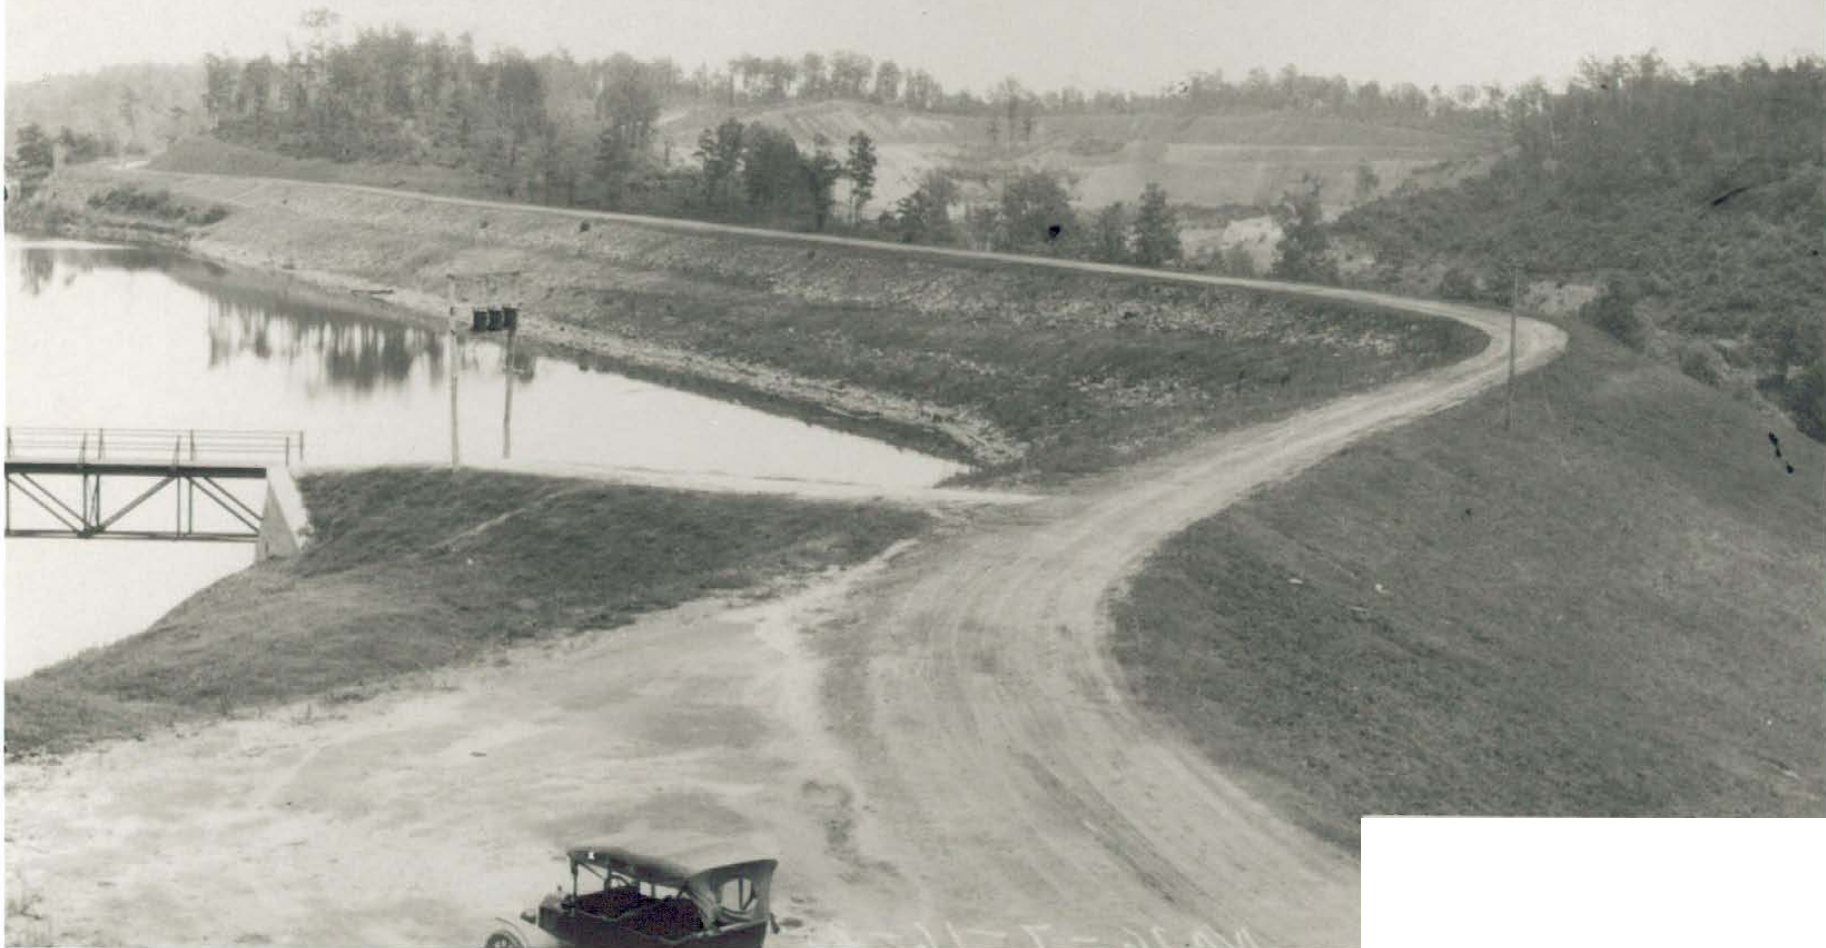
## Hydraulic Fill Dam Completed in 1915

Placement method results in loose, potentially liquefiable embankment shell and soft clay core

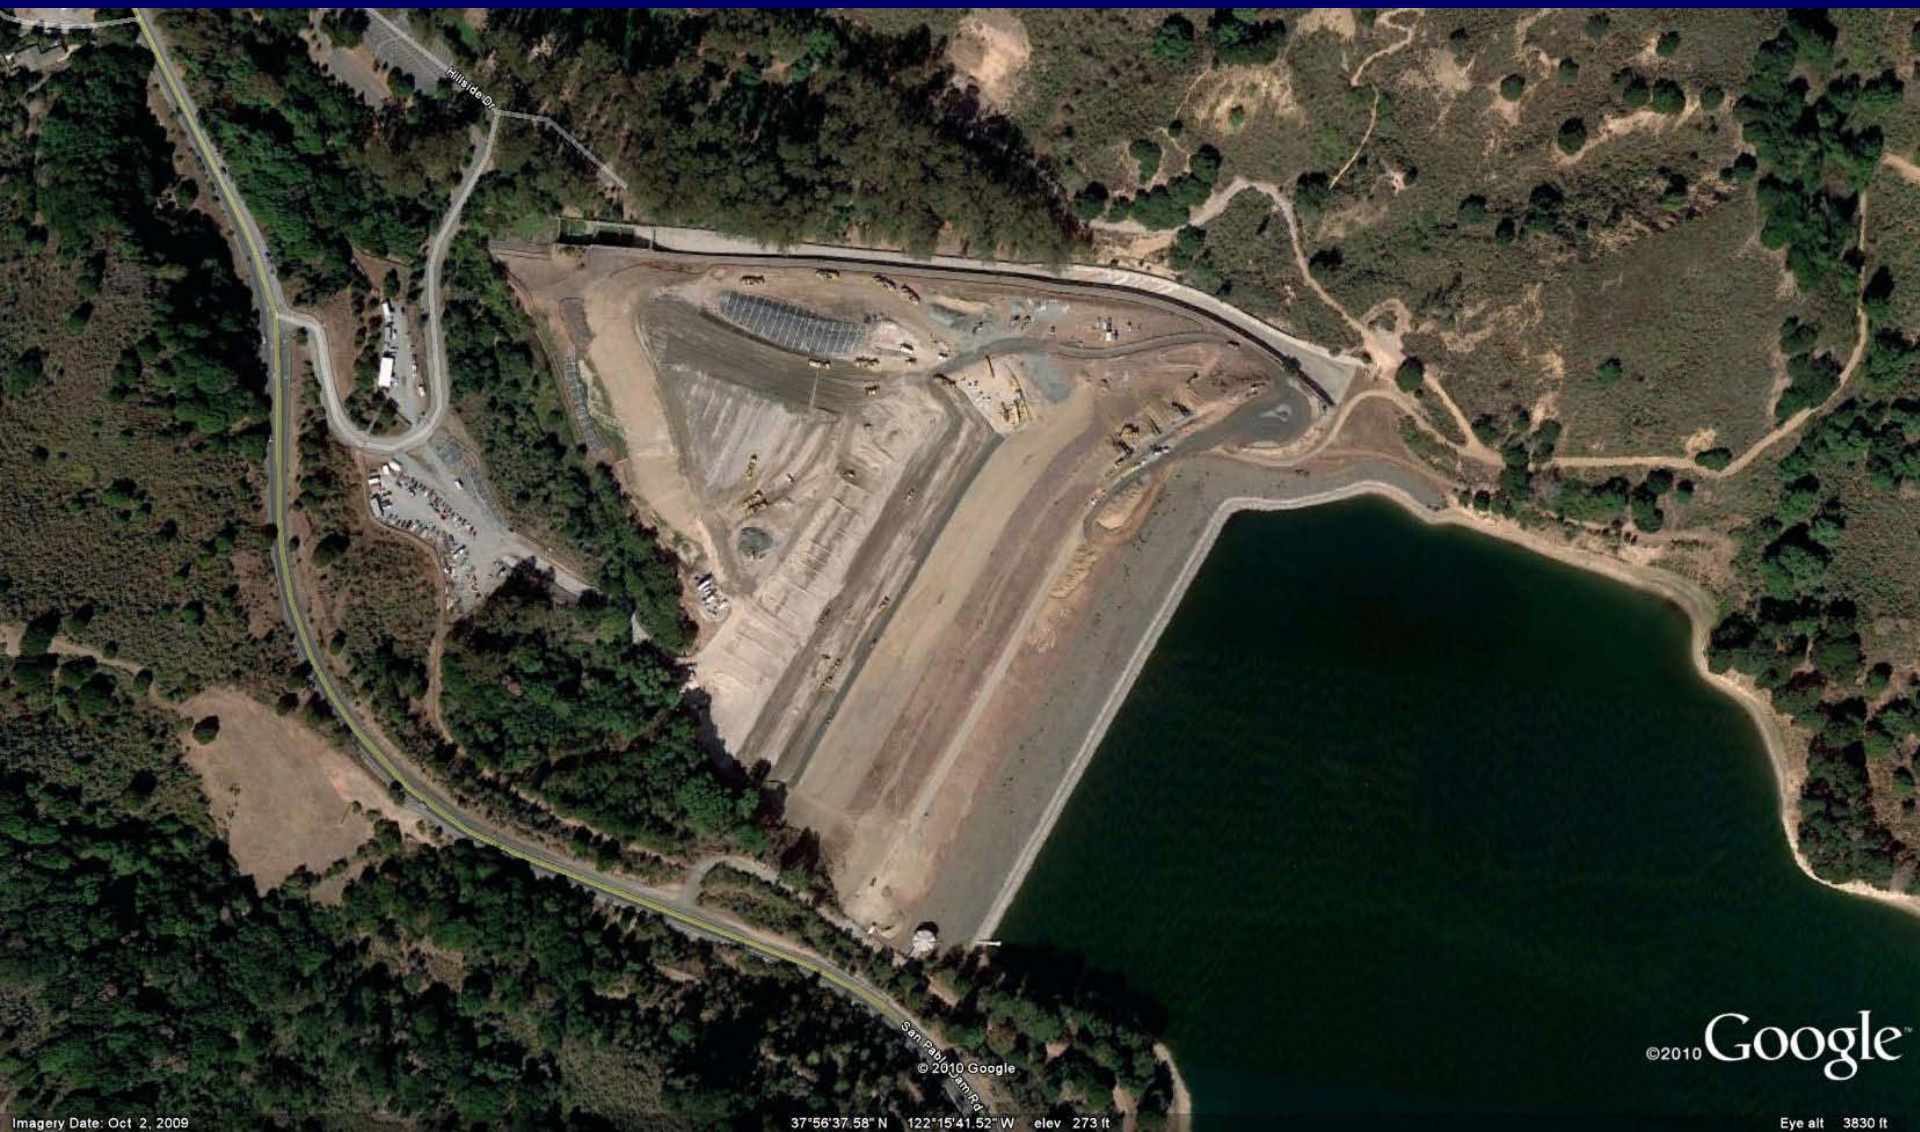
Construction of third retrofit of San Pablo Dam began in Fall 2008 (see *Civil Engineering*, October 2008) - now complete (2010)

# SAN PABLO DAM: Remediated (2009) using Cement Deep Soil Mix Block and Downstream Berm

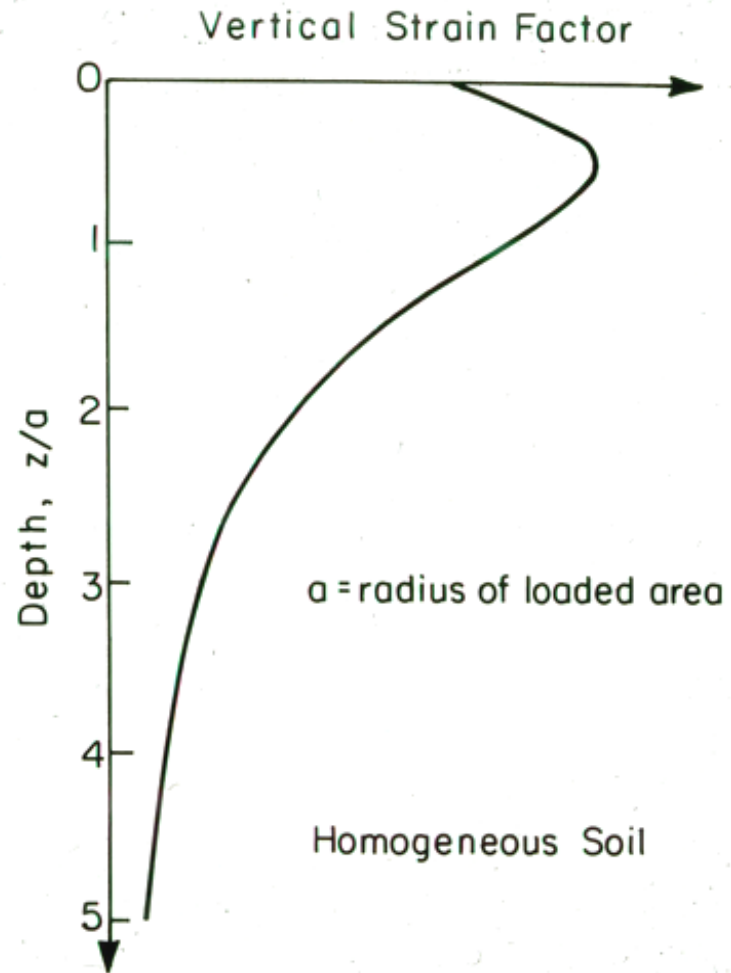
Variation of improvement with depth after DDC is consistent with the strain distribution beneath the weight impact point. Upper limit for densification by DDC is about 35 feet.

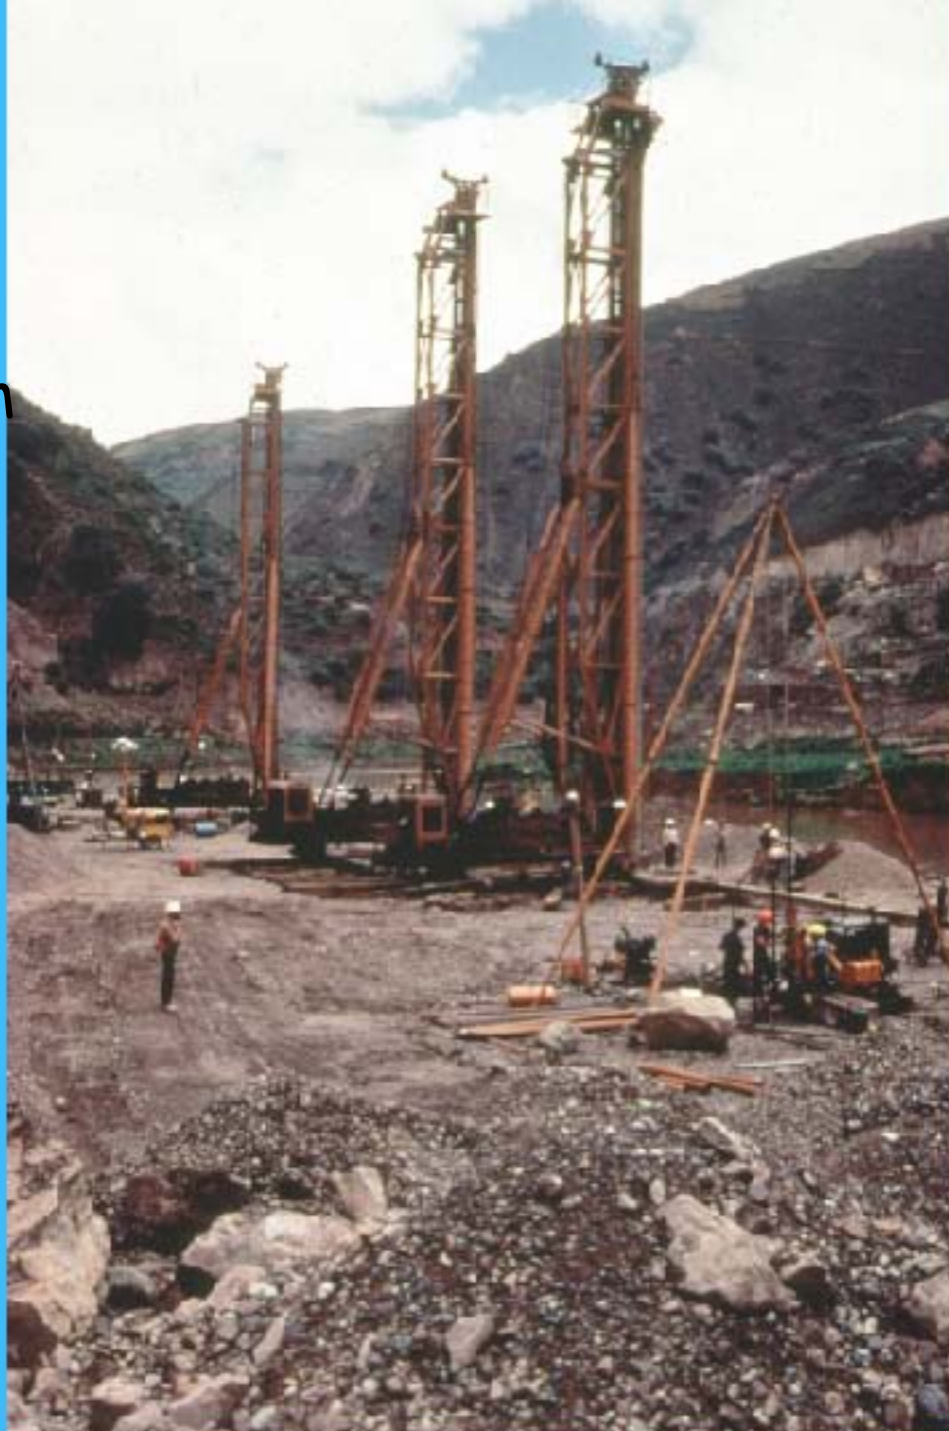
Compaction pile  
construction at  
Tablachaca Dam  
in Peru

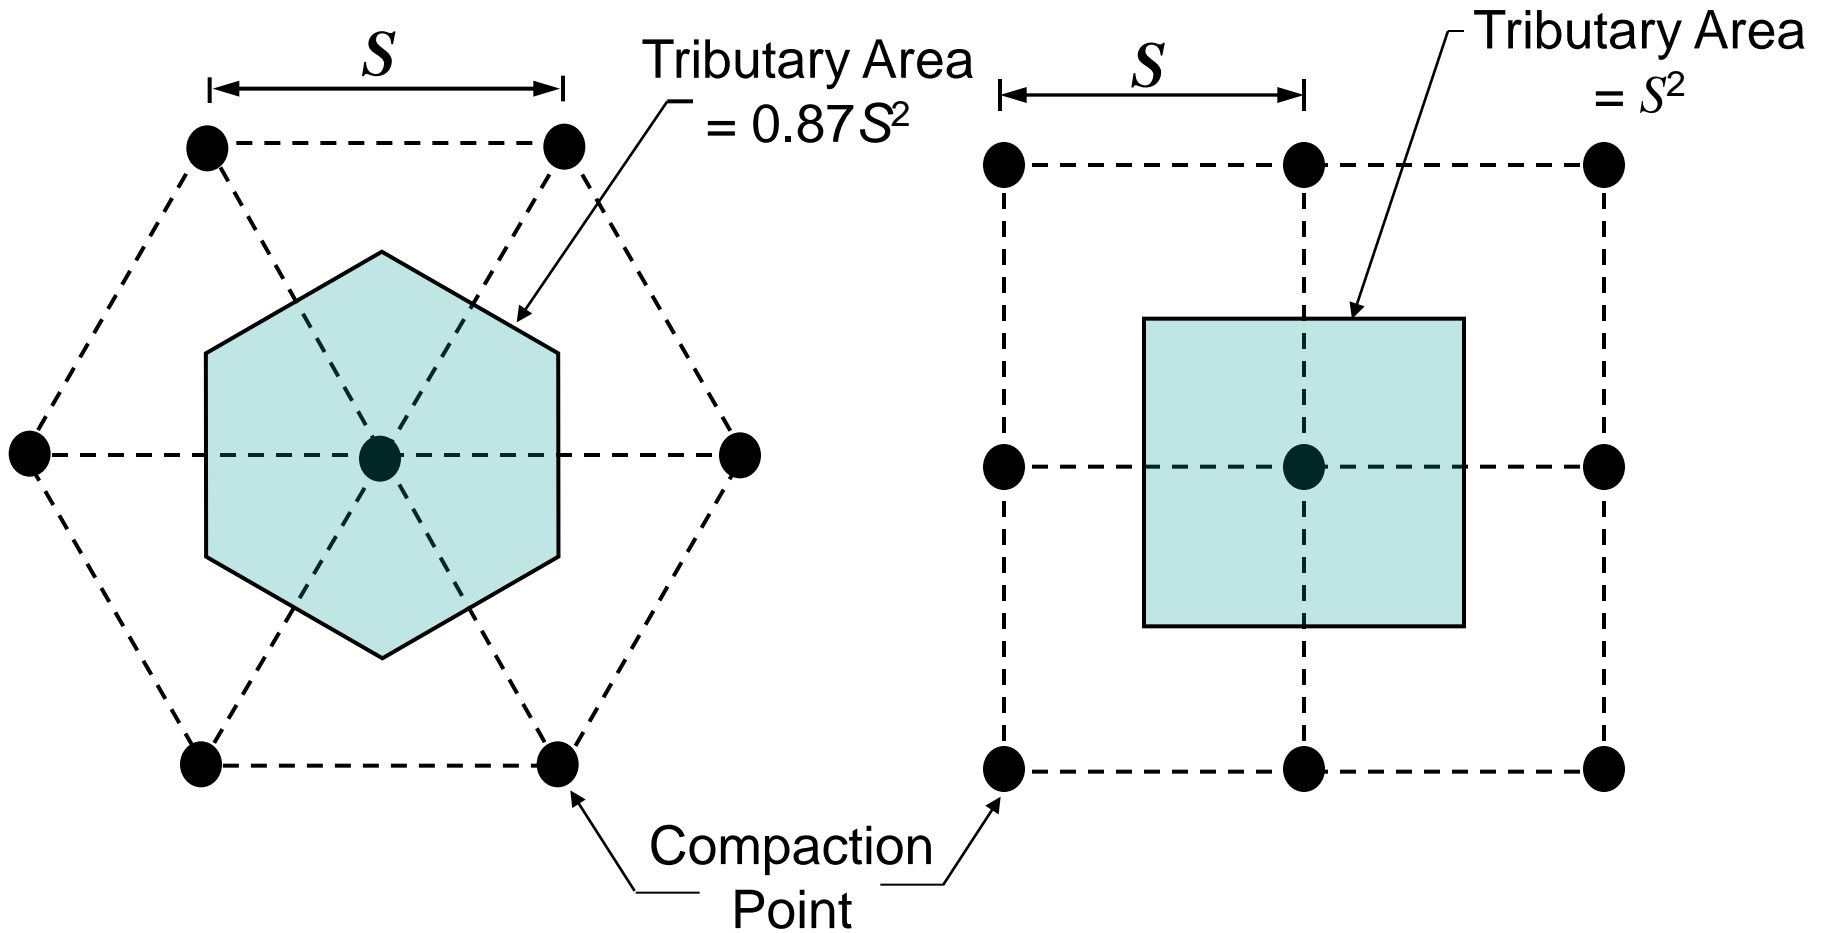
# Typical Patterns used to Treat Large Areas

**Triangular Pattern**

**Square Pattern**

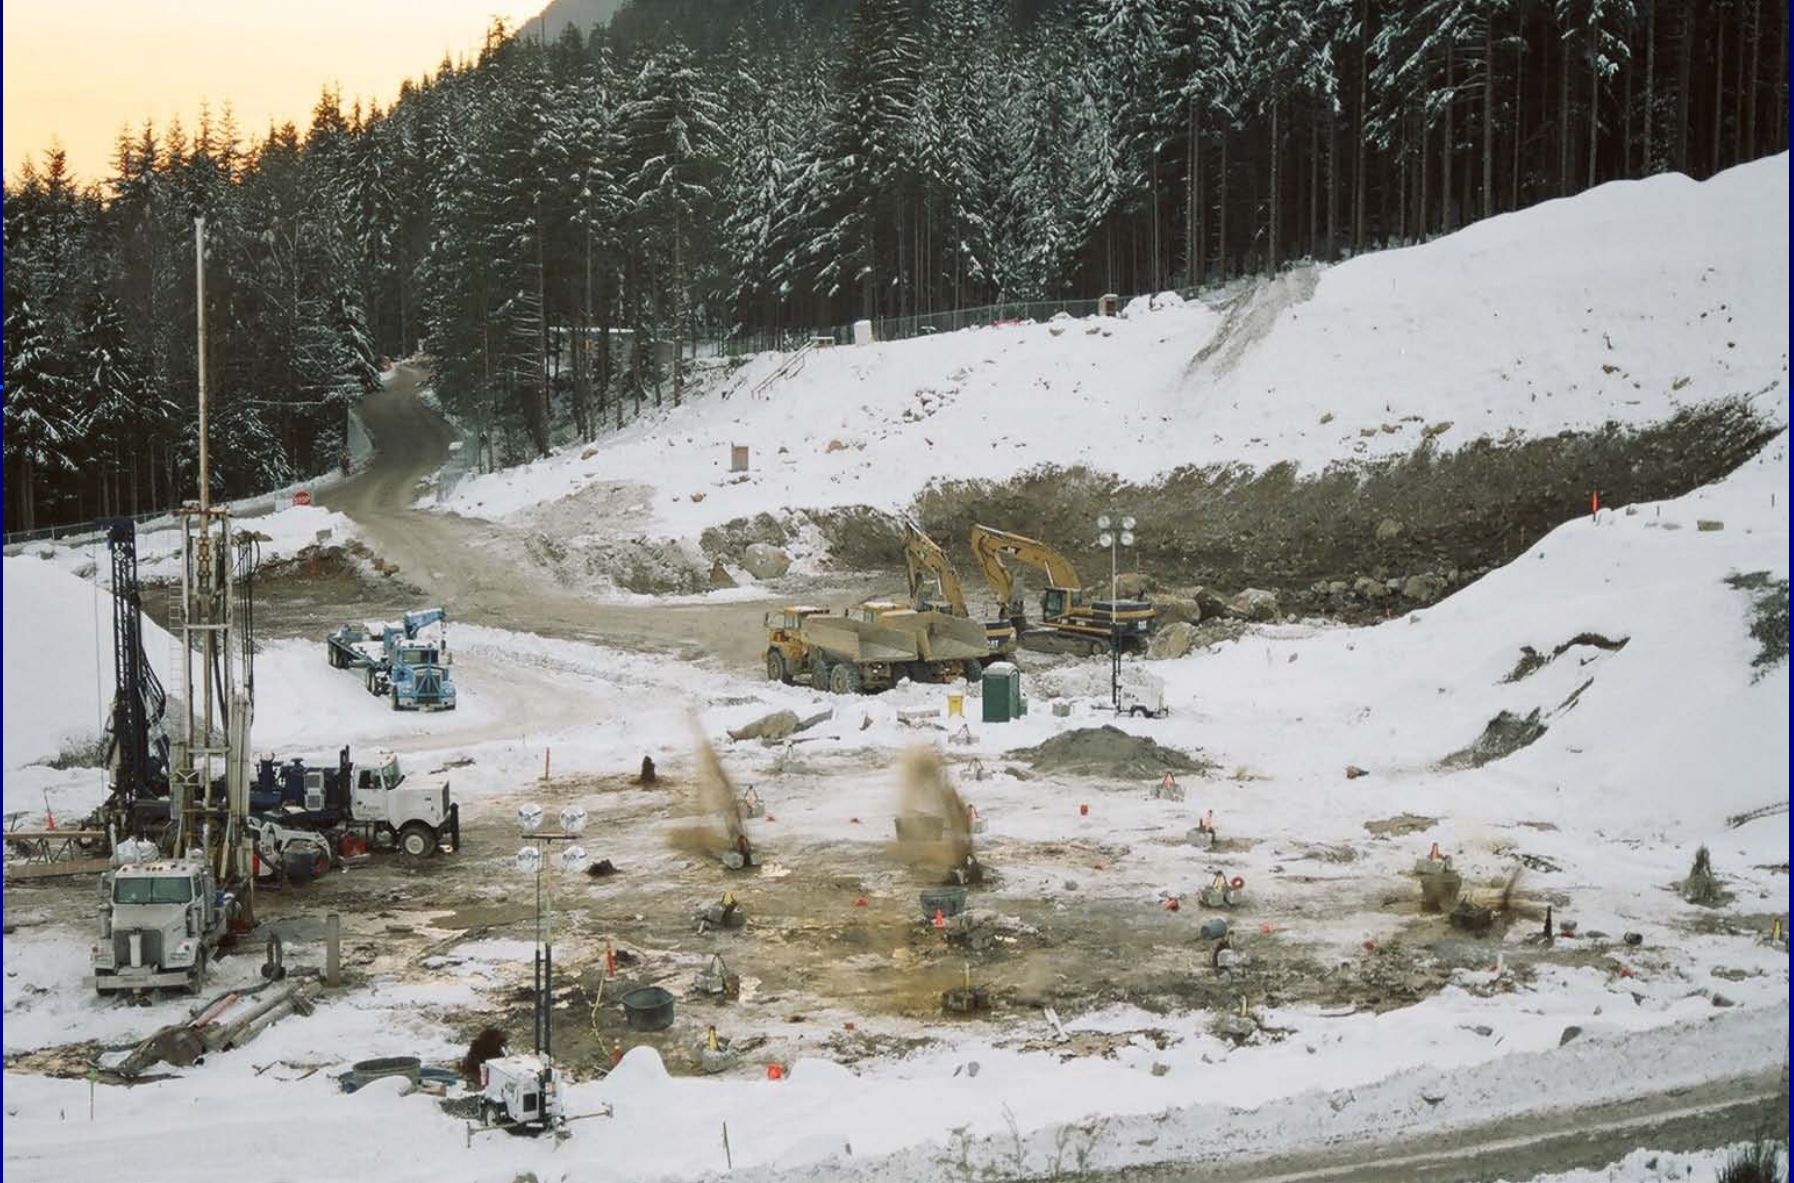
Densification of a high gravel and cobble content layer at Seymour Falls Dam, BC - note gas and water ejecting from blast holes (from Elliott, et al)

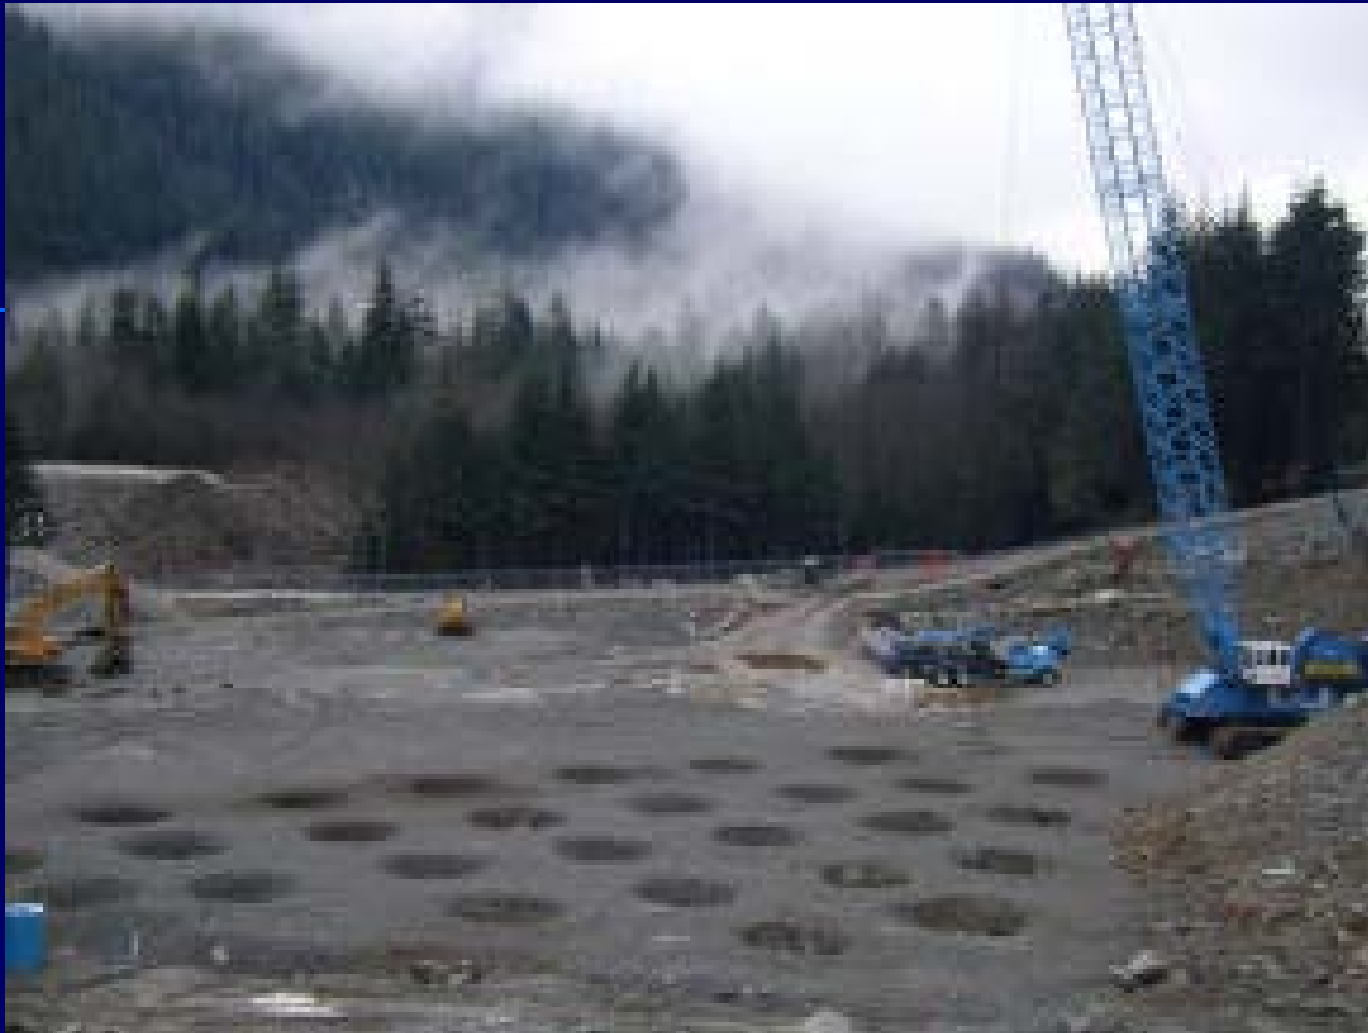
Deep Dynamic Compaction at Seymour Falls Dam  
Most drops were 25 tonnes from 25 meters  
Ave. energy was 550 tonne-m/sq m.  
(from Murray, et al, 2005)

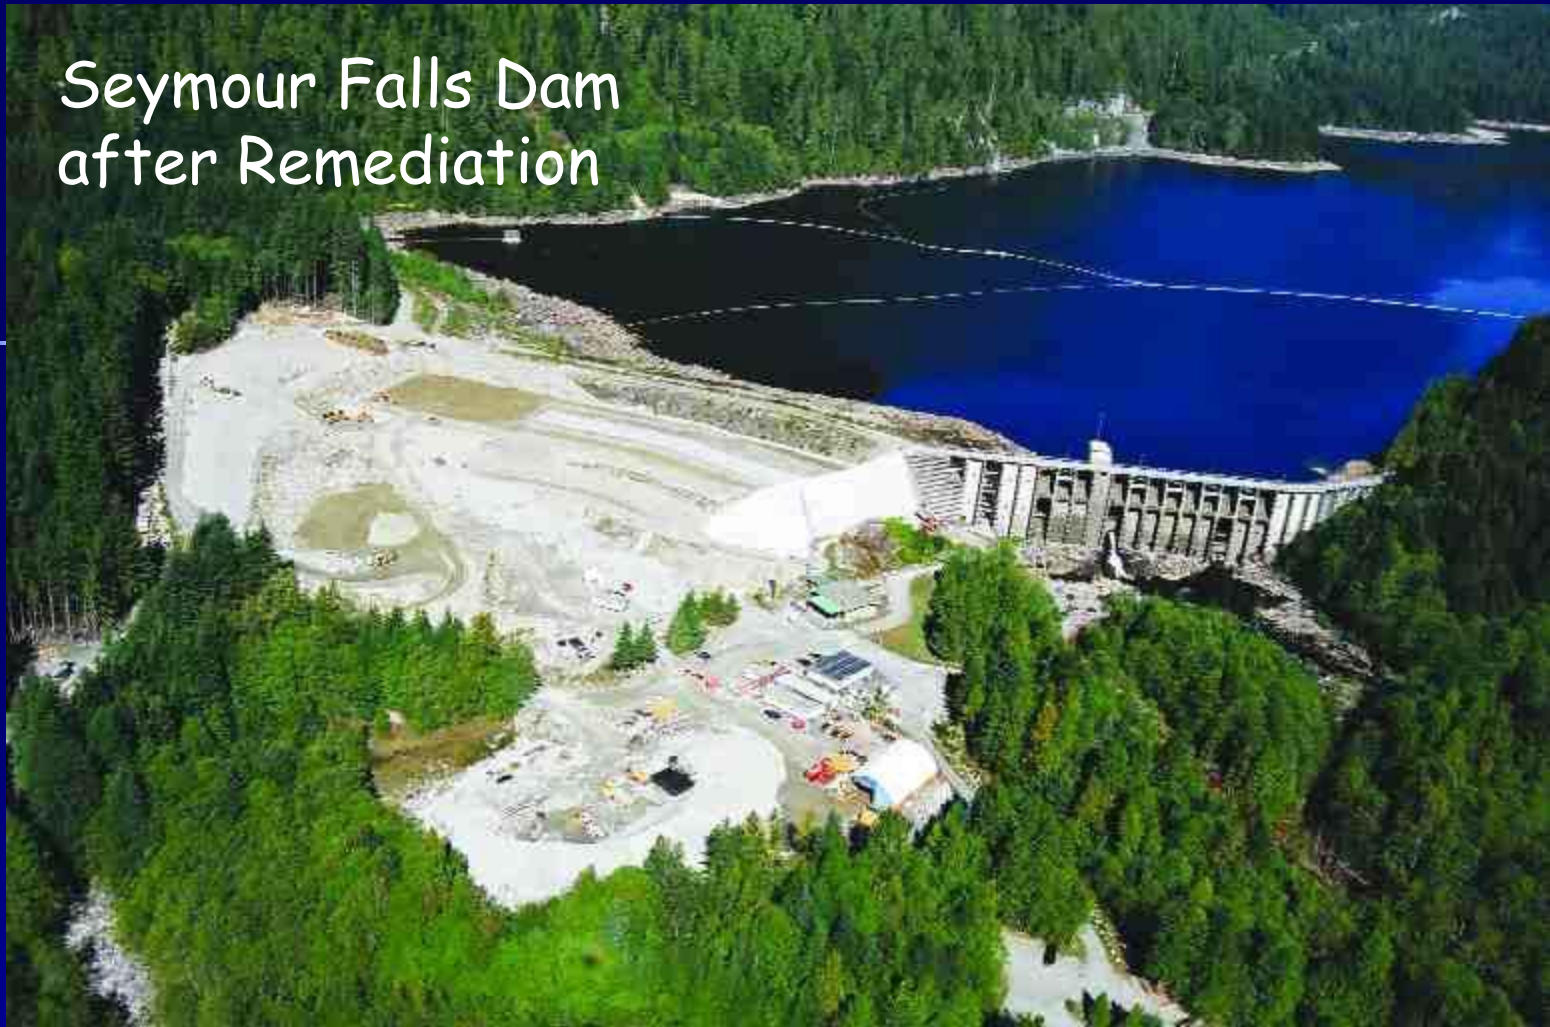
New earthfill dam and gravity wall extension, with the original earthfill dam showing as a grassy ridge along the top; the concrete slab and buttress dam is at right (Canadian Consulting Engineer, October 2007)

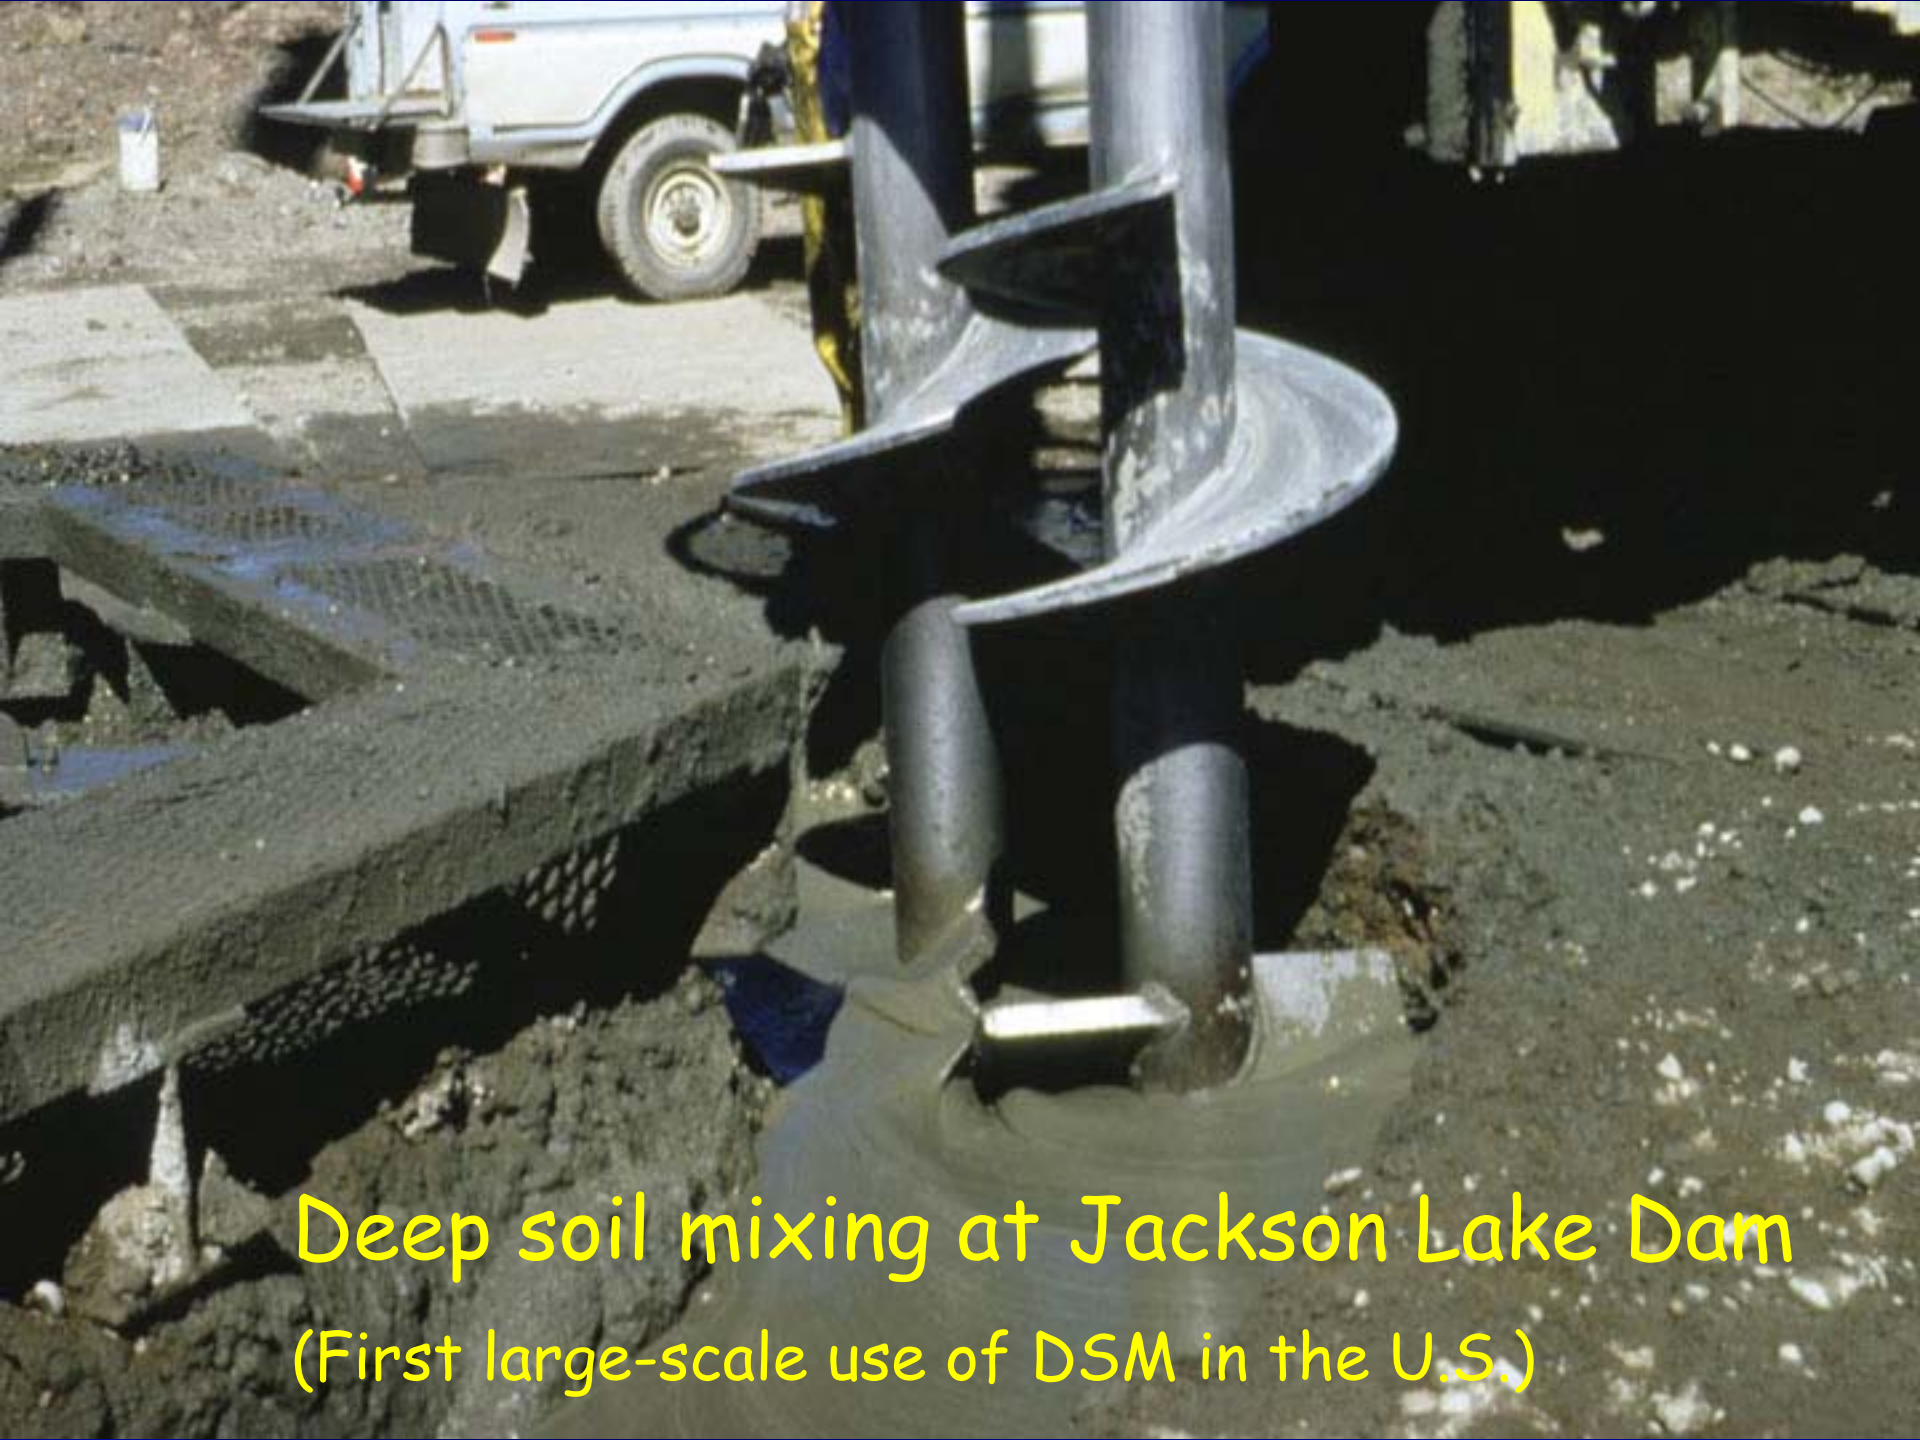
Deep soil mixing at Jackson Lake Dam  
(First large-scale use of DSM in the U.S.)

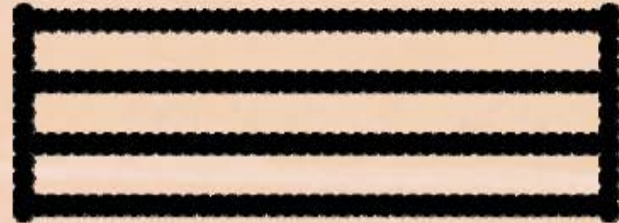
SHEAR WALLS WITH END PANELS

Multi-Auger Walls
