# Ground Improvement for Mitigation of Failure Risks to Existing Embankment Dams

James K. Mitchell, Sc.D., P.E., Dist. M.ASCE

October 6, 2010

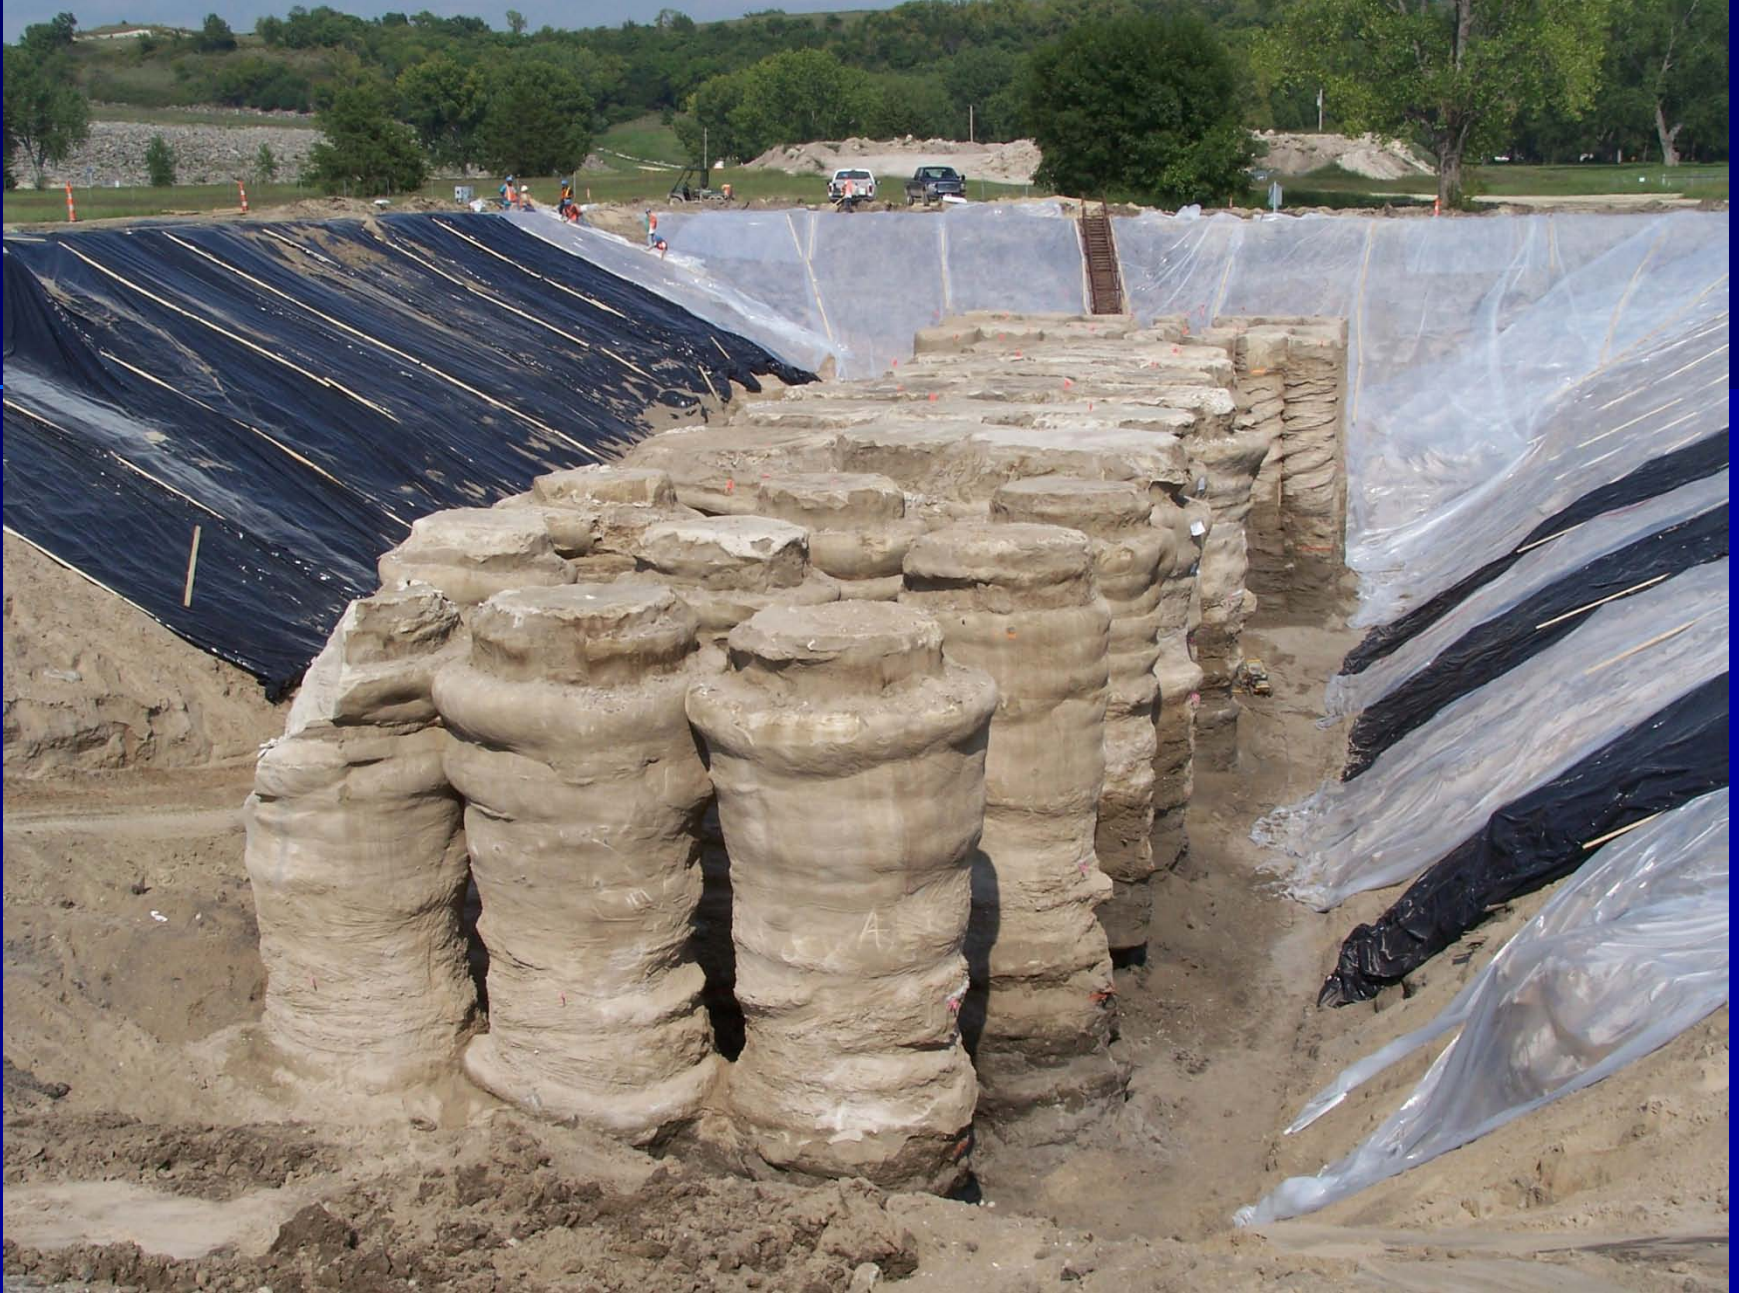
Jet Grout and CDSM Columns at a Recent (2006) Dam Test Section
