Jebba Hydroelectric Development, Nigeria

SOME CASE HISTORIES AND SOME LESSONS

JACKSON LAKE DAM, WYOMING

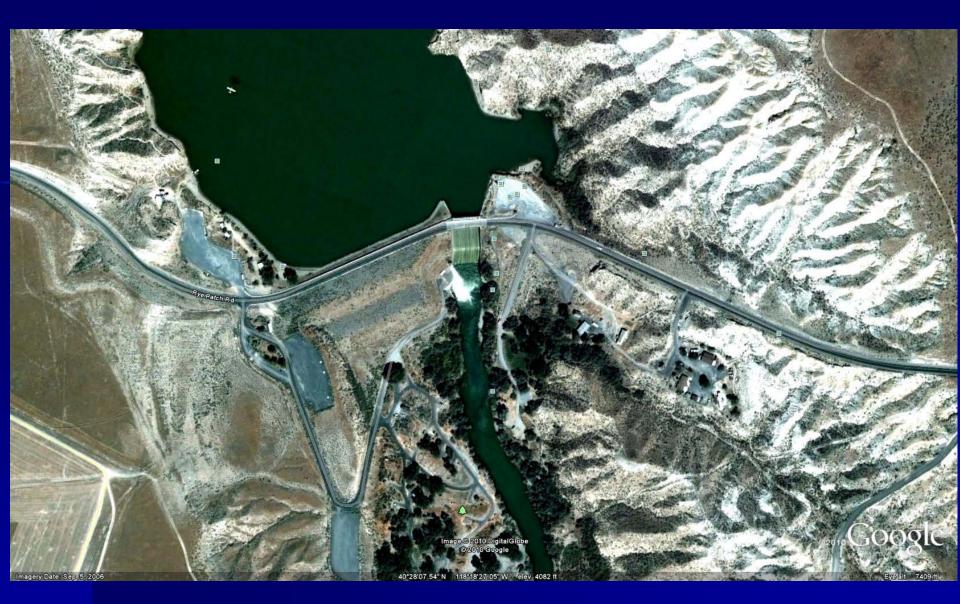
Rye Patch Dam, NV: Remediated in late 1980's using a Soil-Cement Key-block and Downstream Overlay Buttress Fill

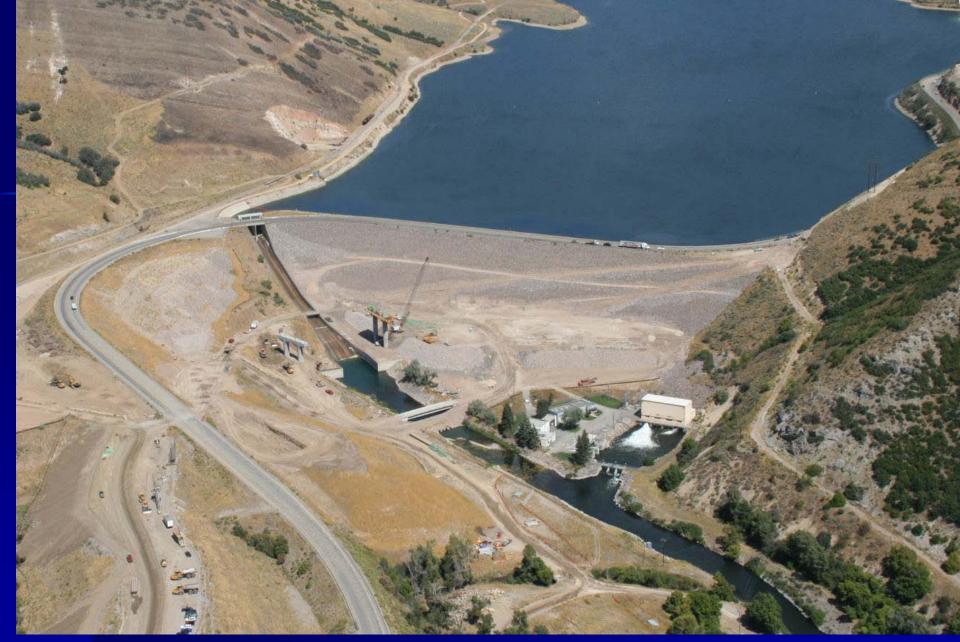
Pier construction for relocated Hwy 189 on DS face of ₉₀ remediated Deer Creek Dam

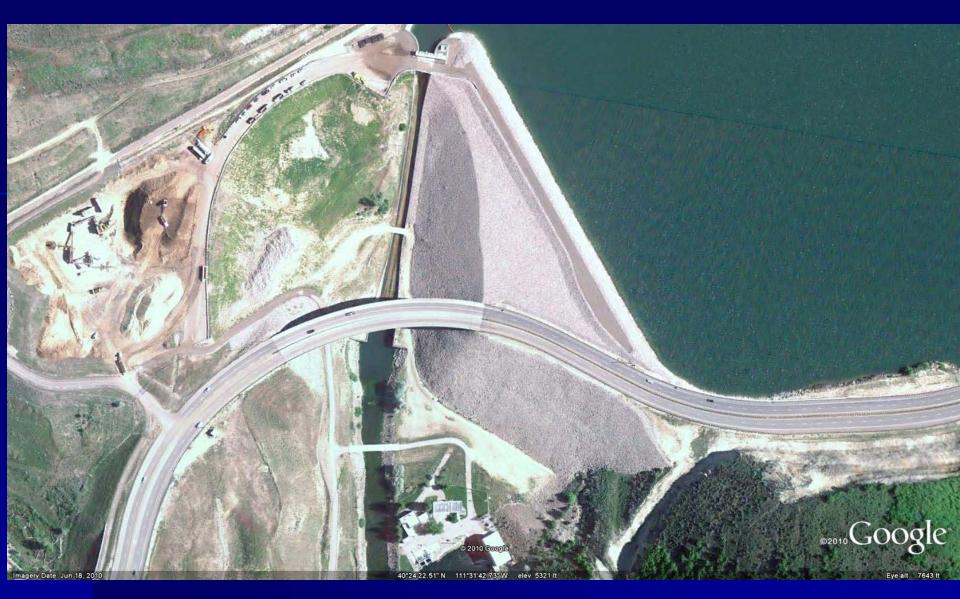
DEER CREEK DAM, Utah: Remediated using Downstream Shear Key and Berm; State Highway relocated over Downstream Embankment Slope
